4. TITLE (and Subtitle) WILLOW CREEK DAM SPILLWAY AND STILLING BASIN AT HEPPNER, OREGON Hydraulic Model Investigation		5. TYPE OF REPORT & PERIOD COVERED

WILLOW CREEK DAM
SPILLWAY AND STILLING BASIN
AT
HEPPNER, OREGON

Hydraulic Model Investigations

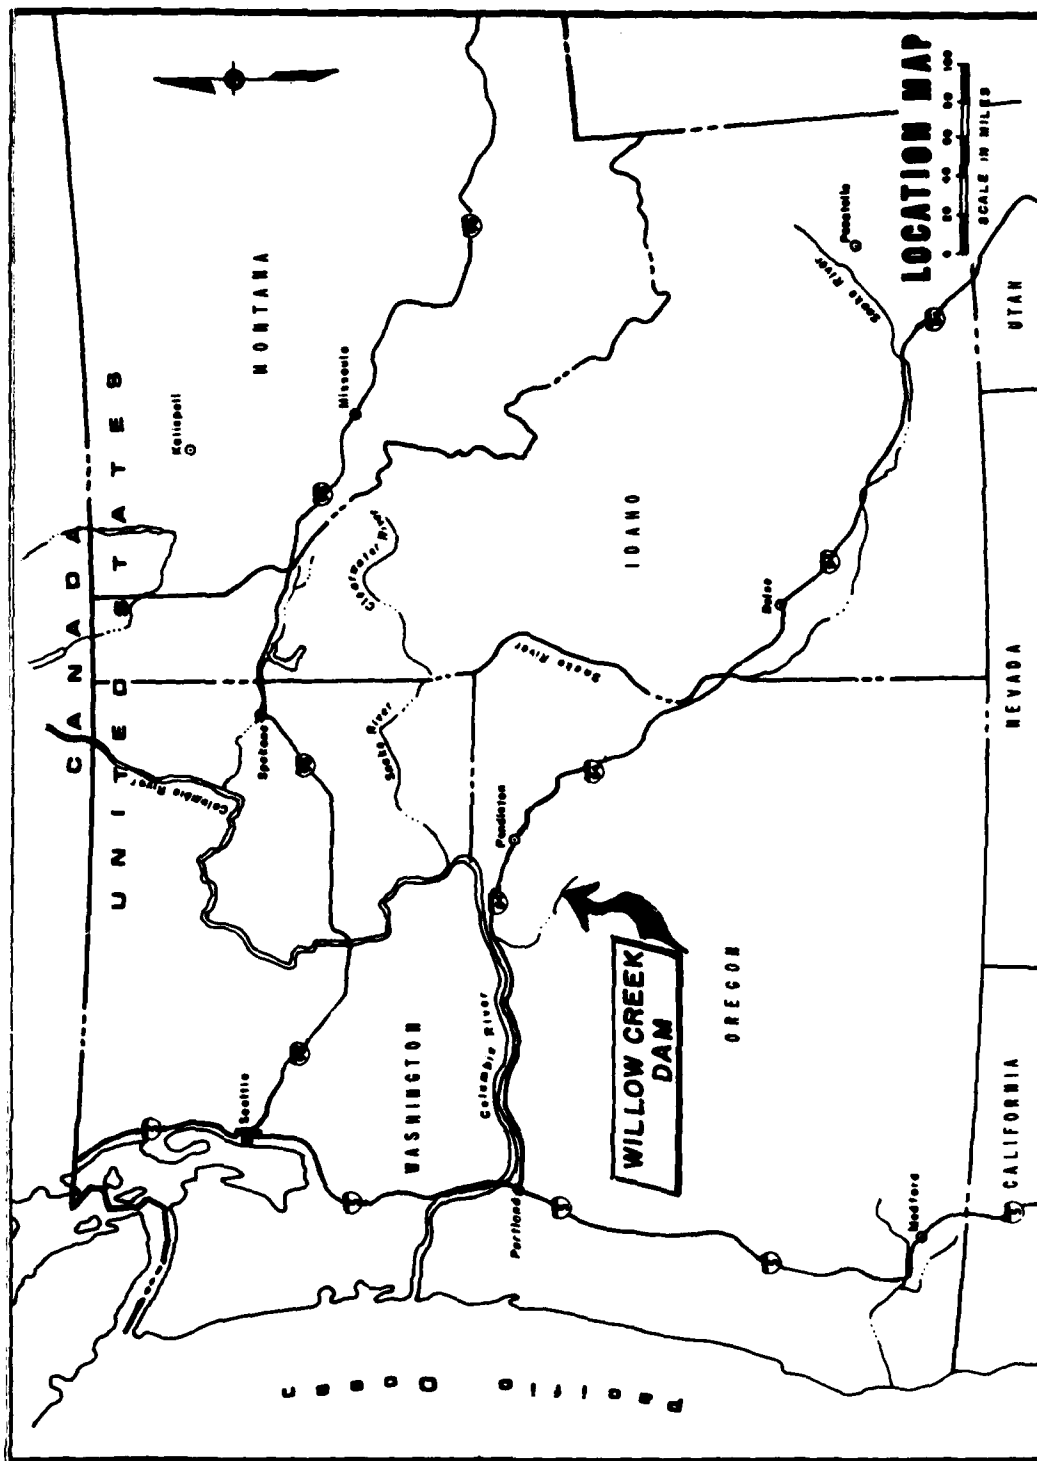
Figure 1

1. Willow Creek project is located on Willow Creek about 47.5 miles upstream from its confluence with the Columbia River and immediately upstream of Heppner, Oregon (figure 1).* The project is a roller compacted concrete (RCC) dam with a spillway and outlet works (plate 1). The dam will create a reservoir with 11,250 acre-feet of exclusive flood control storage and 2,000 acre-feet of storage for other purposes at pool elevation 2113.5 feet.** The project will be operated for flood control, fish, wildlife, recreation, and future irrigation.

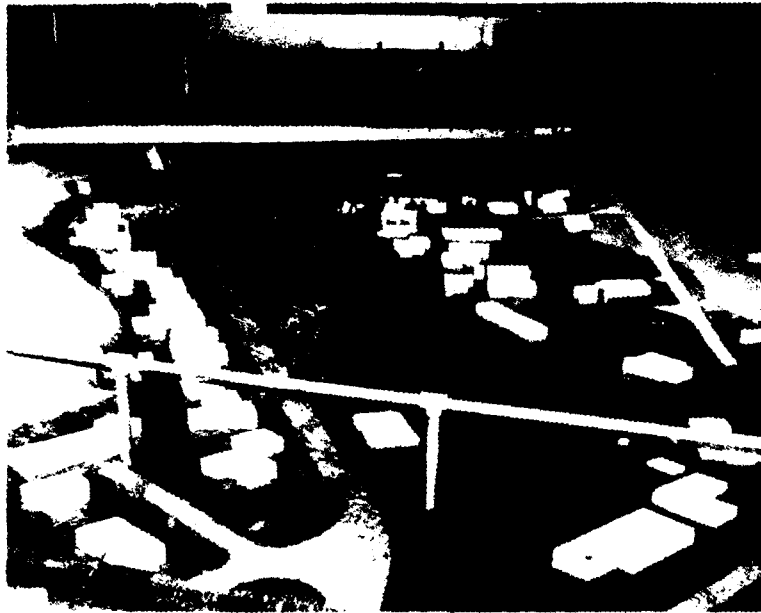
Photograph 2. Existing condition looking upstream at residential area. Unregulated standard project flood; discharge 45,000 cfs

Flow conditions with a discharge of 45,000 cfs, the unregulated summer thunderstorm standard project flood (SPF), are shown in photograph 2 and on plate 2. Velocities over the existing topography were 15 feet per second (fps) just downstream from the dam site, 14 fps at Alfalfa Street bridge, and 19 and 20 fps along Hager Street below Alfalfa Street. Flow conditions with a discharge of 107,000 cfs, the unregulated spillway design flood (SDF), are shown in photograph 3 and on plate 3. Velocities were 18 fps near the damsite and at Alfalfa Street. The water was 30 feet deep in Willow Creek at the downstream end of the test area.

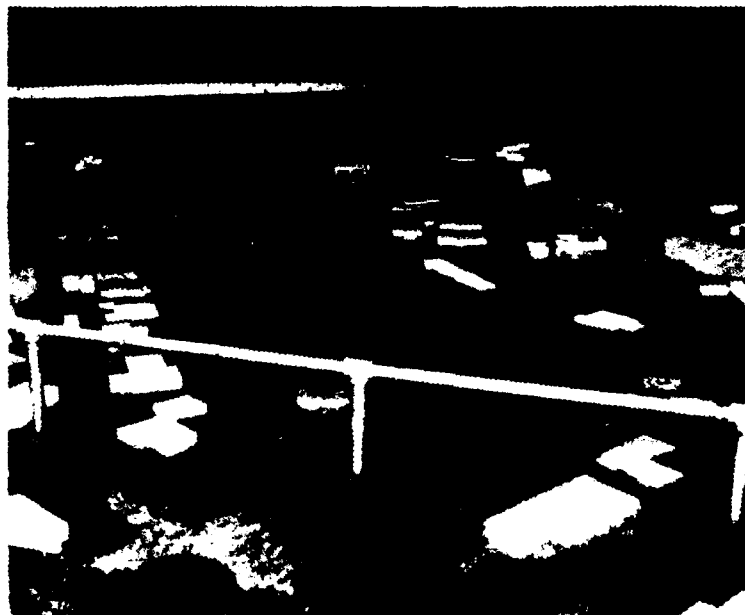
Photograph 3. Existing condition looking upstream at residential area. Unregulated spillway design flood; discharge 107,000 cfs

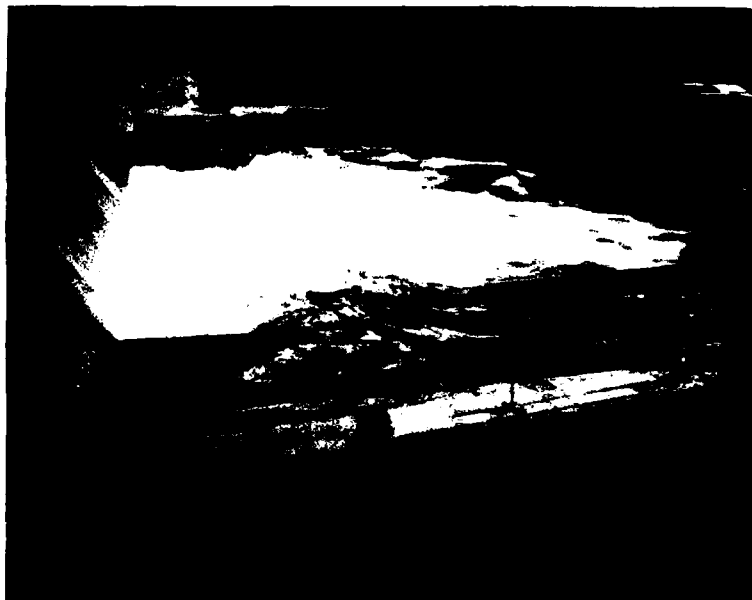
Photograph 4. From right bank. Note severe eddy in stilling basin; discharge 45,000 cfs

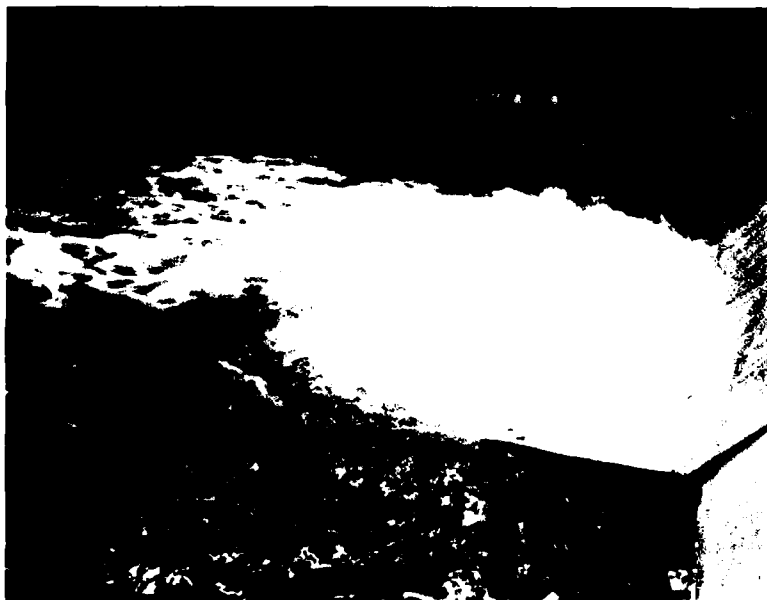
Photograph 5. From left bank; discharge 85,000 cfs

Plan A Stilling Basin

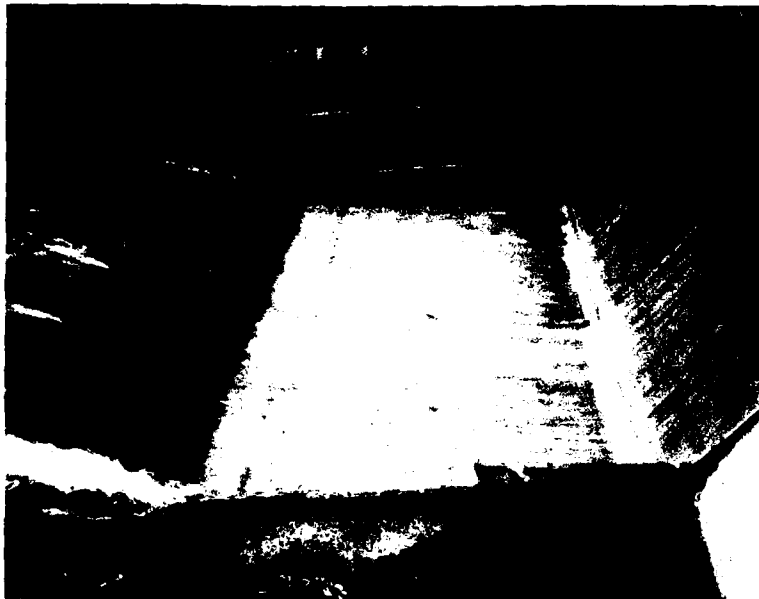
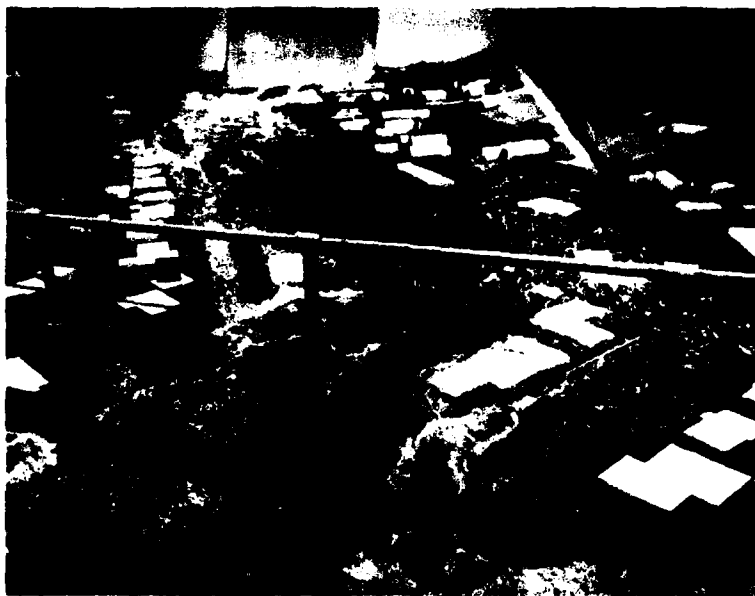
Photograph 6. From left bank

Photograph 7. Looking upstream

Plan A Stilling Basin
Discharge 91,700 cfs

10. The Plan A basin (plate 4), designed for the spillway design flood of 91,700 cfs, was a 66-foot-long concrete apron at elevation 1962.0 feet which continued as a 66-foot-long rock apron at the same elevation. Downstream from the basin apron an excavated runout on a 1 vertical (V) to 10 horizontal (H) slope daylighted at top of rock elevation 1975. Due to the high-velocity flow existing downstream from the project, significant scour may occur during passage of high discharges. In order to evaluate basin performance with a scoured condition, the model was constructed to simulate scour to top of rock elevation 1975 between Willow Creek Road on the right bank and the outlet channel on the left bank from the end of the basin downstream to Alfalfa Street and to remove the Alfalfa Street bridge. Tests were accomplished with discharges of 11,700, 45,000, 85,000, and 91,700 cfs. At 45,000 cfs, a severe eddy formed near the right training wall (photograph 4). The maximum capacity of the basin was 85,000 cfs (photograph 5). At the design discharge of 91,700 cfs the jump was swept out of the basin, and a jump was created by the fill of Alfalfa Street (photographs 6 and 7).

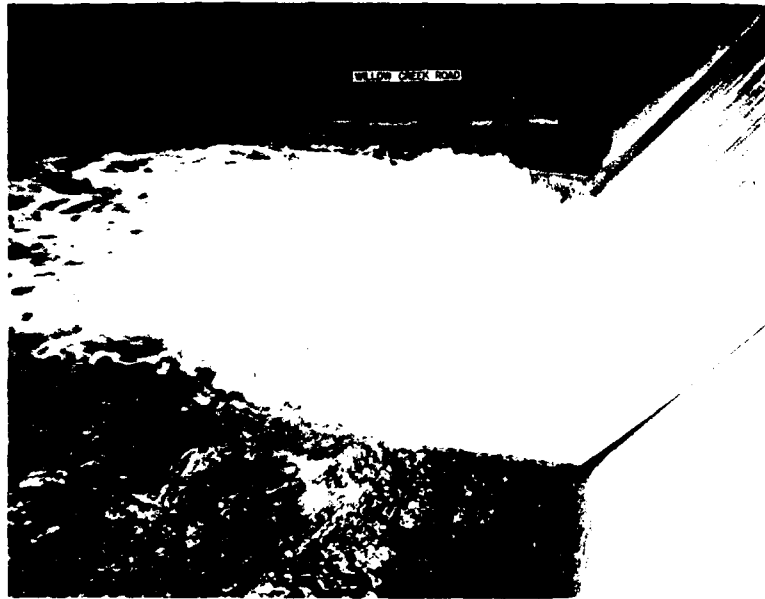
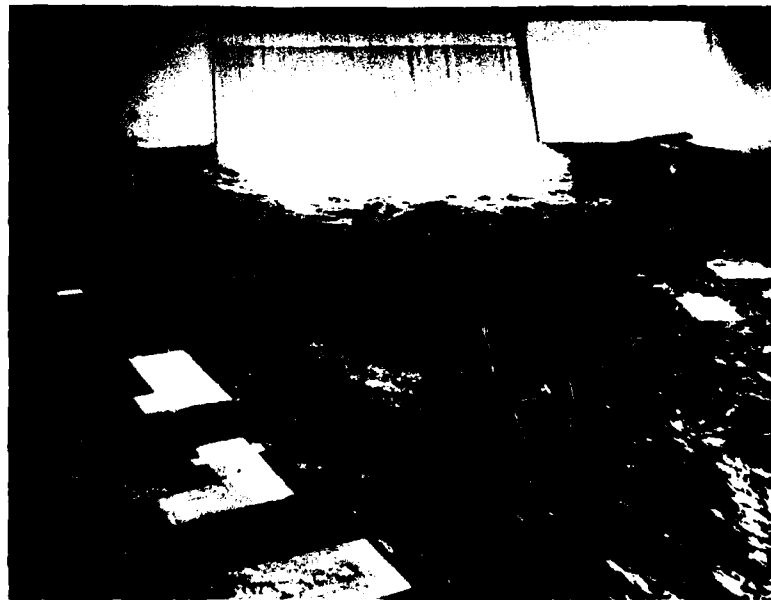
Photograph 8. From left bank; discharge 91,700 cfs

Photograph 9. Looking upstream; discharge 91,700 cfs

Plan A Stilling Basin With 4-Foot-High End Sill

11. The addition of a 4-foot-high sloping end sill at the downstream end of the concrete apron was sufficient to contain the hydraulic jump within the basin apron and runout slope for all discharges up to 91,700 cfs (photographs 8 and 9). At the design discharge and with the end sill added, velocities on the excavated runout slope were 15 fps and velocities over the simulated scoured area downstream from the runout and near Alfalfa Street were 12-13 fps (plate 5).

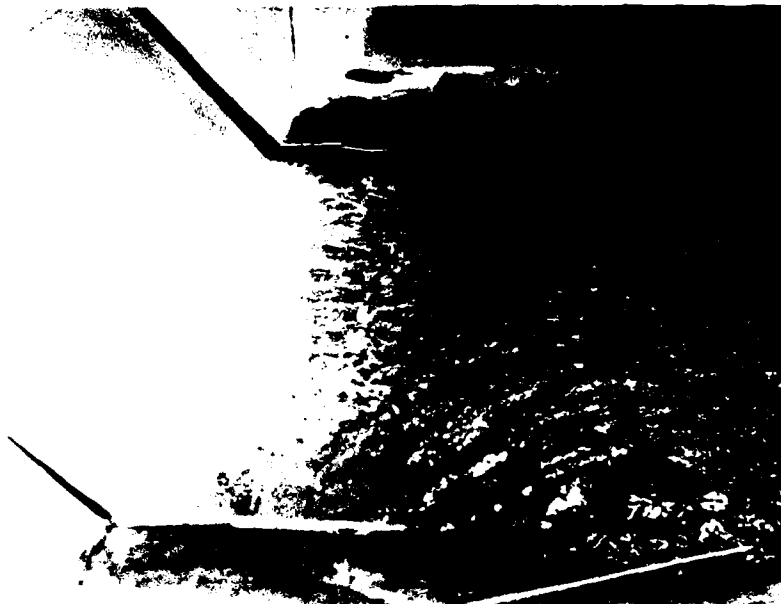
Photograph 10. From right bank; discharge 11,700 cfs

13. With the basin design discharge of 11,700 cfs, a good hydraulic jump formed totally within the basin (photograph 10). Velocities were 10 fps just downstream from the end sill, 6 fps at the washed out Alfalfa Street bridge, and 12 fps in the creek approximately 100 feet farther downstream (photograph 11 and plate 6). With 15,000 cfs the jump began to sweep out of the basin (photograph 12), and velocities were 11 fps downstream from the sweepout, 6 fps at the bridge, and 14 fps 100 feet beyond the bridge. A flow of 45,000 cfs caused a complete sweepout of the basin (photograph 13) and velocities of 19, 14, and 21 fps at the locations previously noted. The regulated spillway design flood of 91,700 cfs was flipped from the basin for about 200 feet downstream and created velocities of 49 fps upstream from Alfalfa Street, 28 fps at the bridge, and 37 fps 100 feet farther downstream (photographs 14 and plate 7). Depth in the creek near the downstream end of the test area (gage 4) was 2.3 feet lower than with the same unregulated flood. Flooding downstream from Alfalfa Street with the spillway design flood is shown in photograph 15.

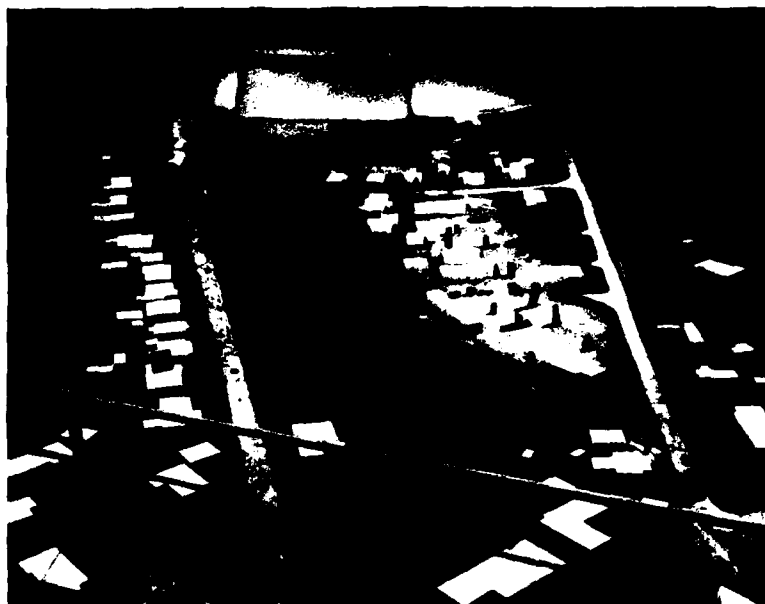
Photograph 11. Looking upstream; discharge 11,700 cfs

Plan B Stilling Basin

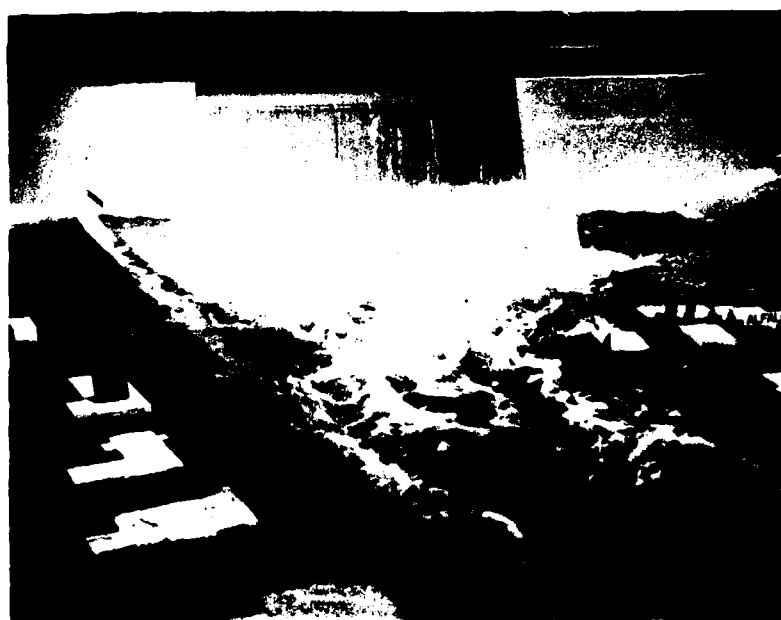
Photograph 15. Looking upstream through residential area

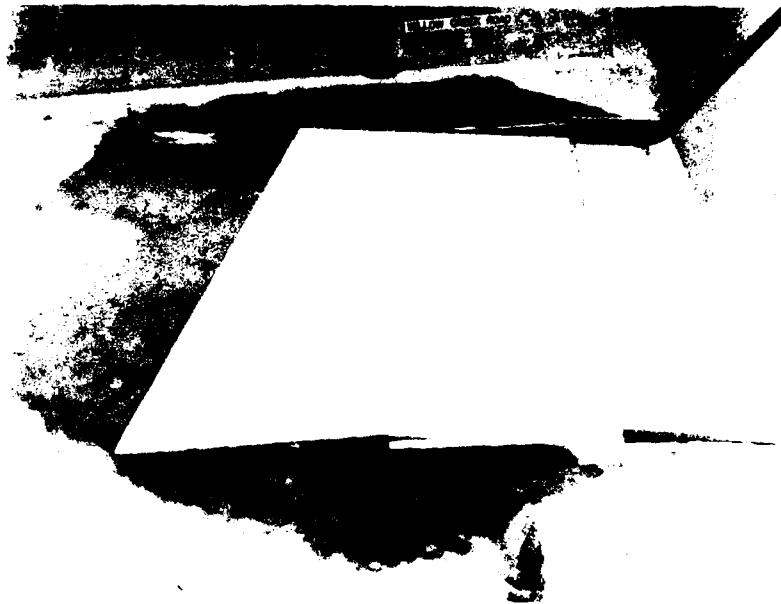
Photograph 16. Dry bed

14. The basin recommended for final design was sized for the regulated winter PMF of 18,000 cfs. The length of the basin was 66 feet and the floor was at elevation 1970.75 with a 4.25-foot-high sloping end sill to elevation 1975, the approximate top of rock (photograph 16 and plate 4). A good hydraulic jump occurred in the basin with discharge of 11,700 cfs (regulated summer thunderstorm SPF) and 18,000 cfs (photographs 17 and 18). Velocities were 6 to 8 fps in the simulated scoured

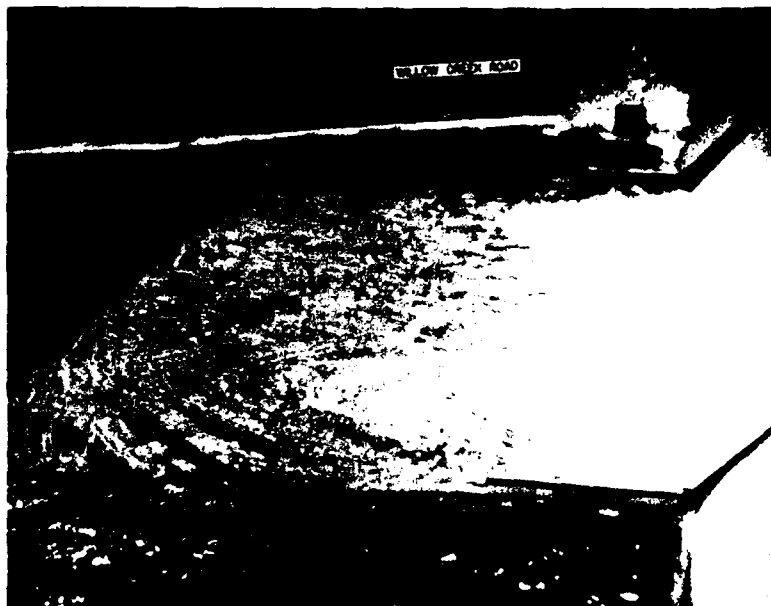
Photograph 18. Discharge 18,000 cfs

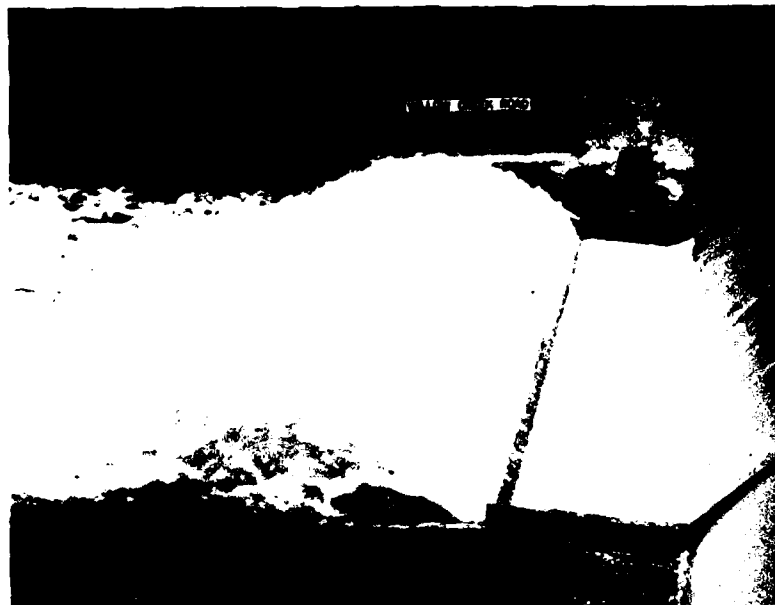
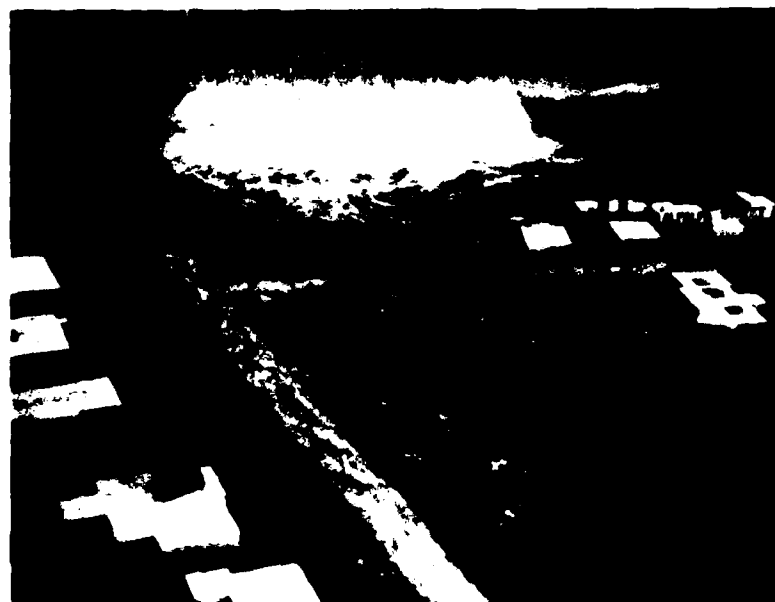
Photograph 20. Discharge 45,000 cfs

Photograph 21. Looking upstream through residential area; discharge 45,000 cfs

Plan C Stilling Basin (Recommended Plan)
With Alfalfa Street Bridge Washed Out

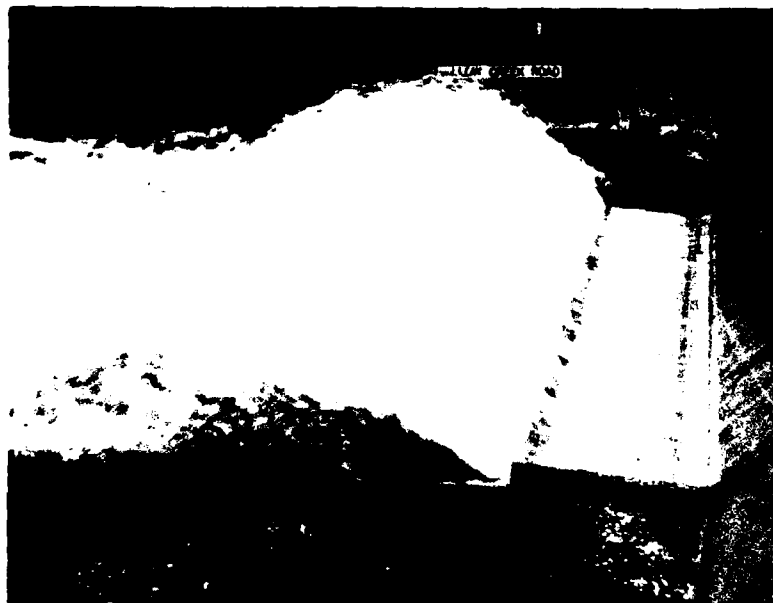
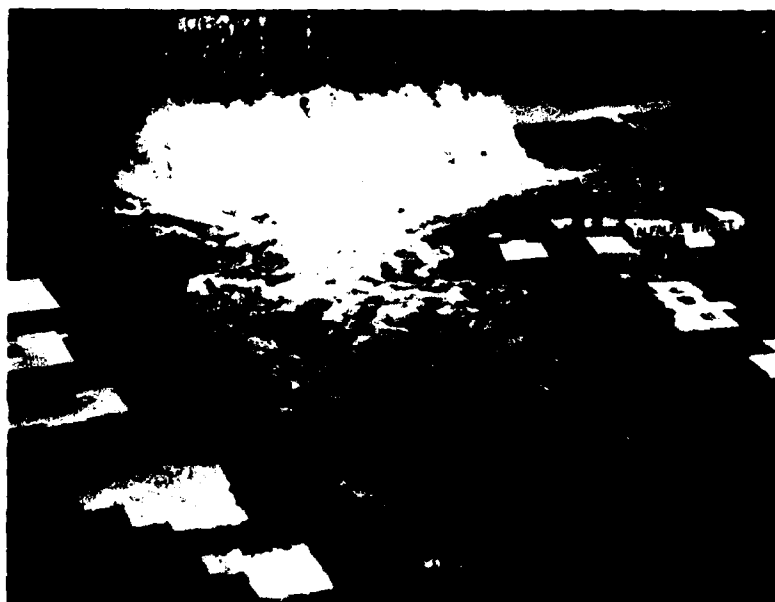
Photograph 22. From left bank

Photograph 23. Looking upstream through residential area

Plan C Stilling Basin (Recommended Plan)
 With Alfalfa Street Bridge Washed Out
 Regulated Spillway Design Flood; Discharge 91,700 cfs

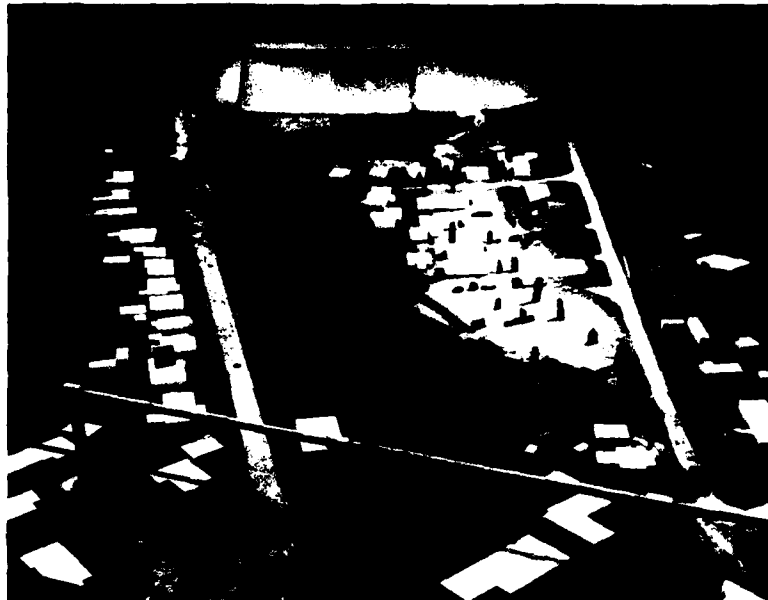
Photograph 24. Looking upstream through residential area. Regulated standard project flood; discharge 11,700 cfs

area just downstream from the basin, 6 fps at Alfalfa Street bridge, and 12 and 14 fps 100 feet farther downstream (plates 8 and 9). With a discharge of 24,000 cfs, the jump began to sweep from the basin (photograph 19). Velocities in the simulated scoured area were as high as 17 fps. Velocities were 6 fps at the bridge and 14 fps 100 feet downstream (plate 10). With 45,000 cfs, velocities were 37 fps downstream from the sweepout, 12 fps at the bridge, and 18 fps 100 feet downstream (photographs 20 and 21 and plate 11). With the spillway design flood of 91,700 cfs, velocities were 48 fps downstream from the sweepout, 26 fps at the bridge, and 36 fps about 100 feet downstream (photographs 22 and 23 and plate 12). Flooding conditions with the regulated thunderstorm SPF and the SDF are shown in photographs 24 and 25.

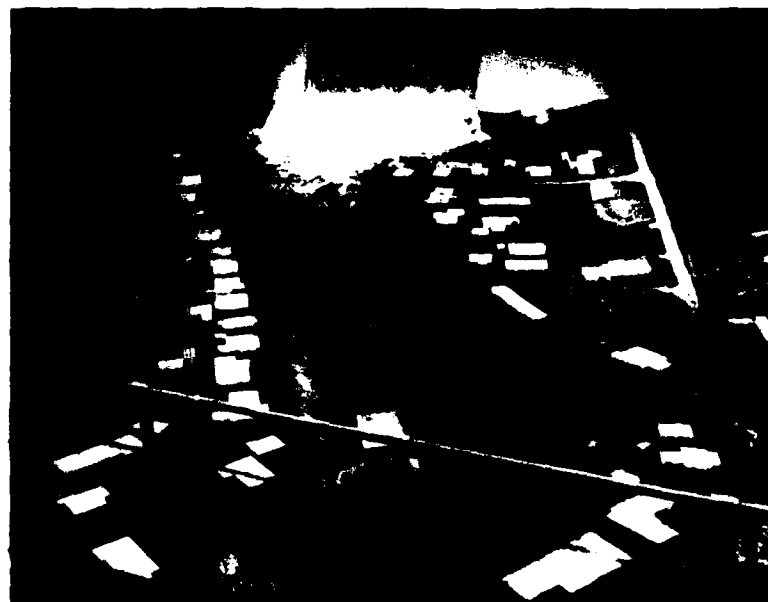
Photograph 25. Looking upstream through residential area. Regulated spillway design flood; discharge 91,700 cfs

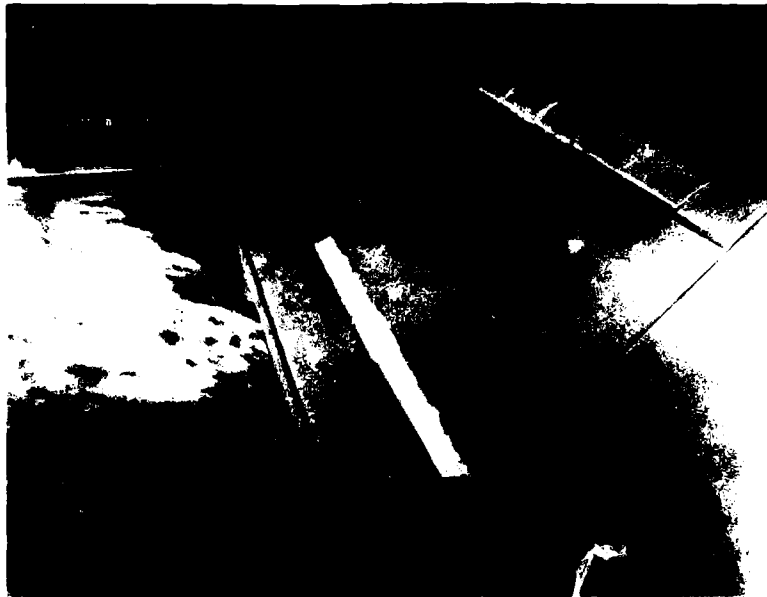
Photograph 26. Dry bed from left bank

Photograph 27. Dry bed looking upstream

Plan C Stilling Basin With Unscoured Overburden Downstream

15. Performance of the Plan C basin was also evaluated assuming no scouring would occur downstream from the basin (photographs 26 and 27). Flow conditions assuming no scour of the overburden downstream with discharges of 11,700 and 18,000 cfs are shown on plates 13 and 14. Velocities across the overburden were 11 and 12 fps. Velocities were 12 and 13 fps under the Alfalfa Street bridge and 12 and 14 fps just downstream from the bridge. The velocities in the area upstream of the bridge were approximately double those occurring with the area assumed to be scoured to rock. A good hydraulic jump formed in the basin with both flood discharges (photographs 28 and 29). Maximum water surface behind the basin walls was at elevation 1989.0, 1 foot below the walls (plate 14). The jump began to sweep out of the basin with a discharge of 38,800 cfs (photograph 30 and plate 15).

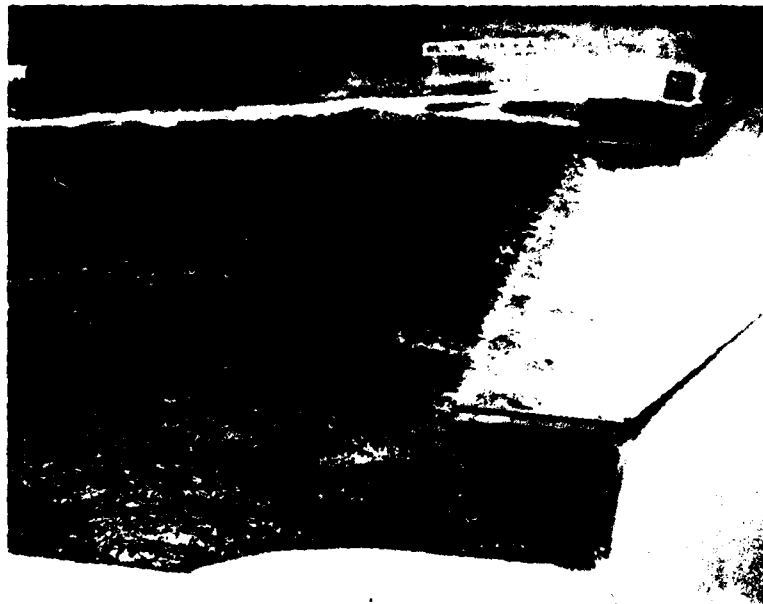
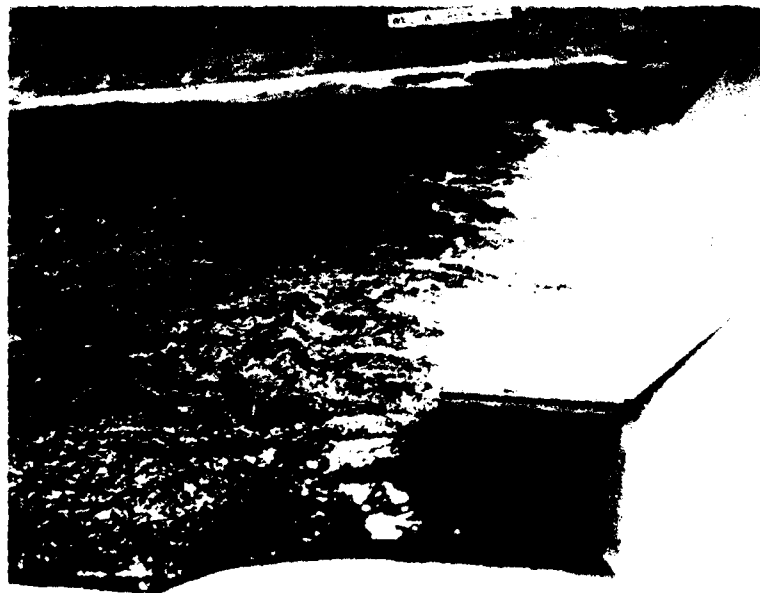
Photograph 28. Discharge 11,700 cfs

Photograph 29. Discharge 18,000 cfs

Plan C Stilling Basin With Unscoured Overburden Downstream

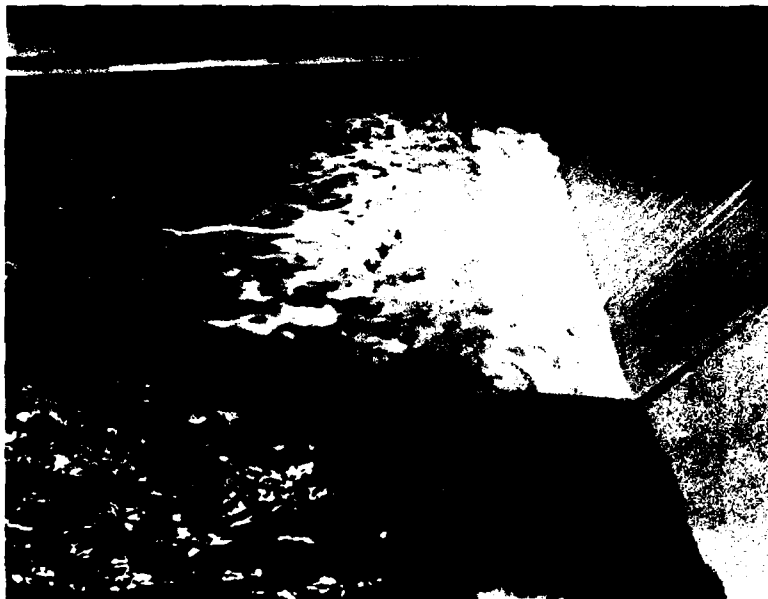
Photograph 30. Basin sweepout; discharge 38,800 cfs

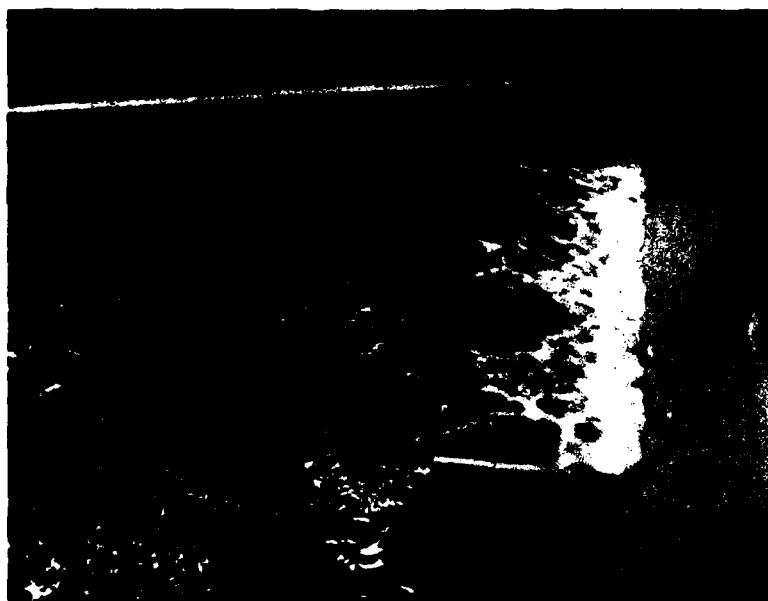
Photograph 31. Without bucket radius (final design);
discharge 18,000 cfs

16. The Plan C stilling basin without a curved bucket (plate 16) also performed well and was selected as the final design. A good hydraulic jump formed in the basin with the design discharge of 18,000 cfs (photograph 31). Impact pressures on the basin floor 26 inches from the intersection with the spillway chute were 77 feet of water with a discharge of 91,700 cfs, 59 feet with 65,000 cfs, and 43 feet with 45,000 cfs.

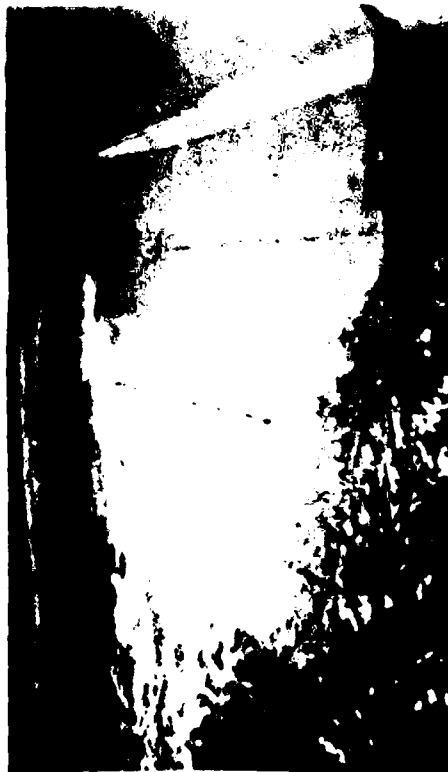
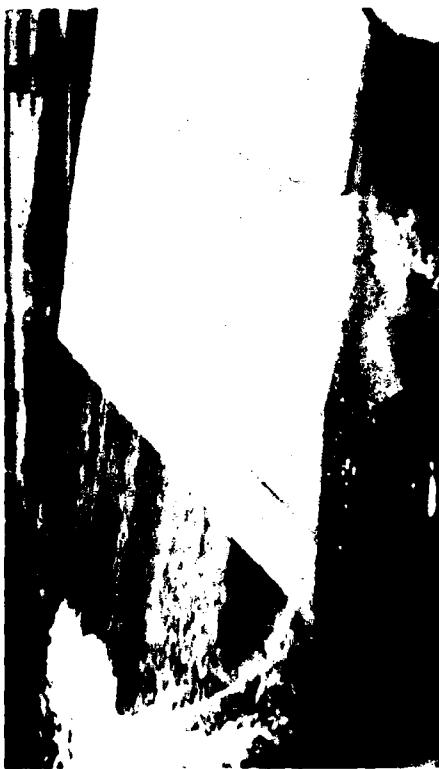
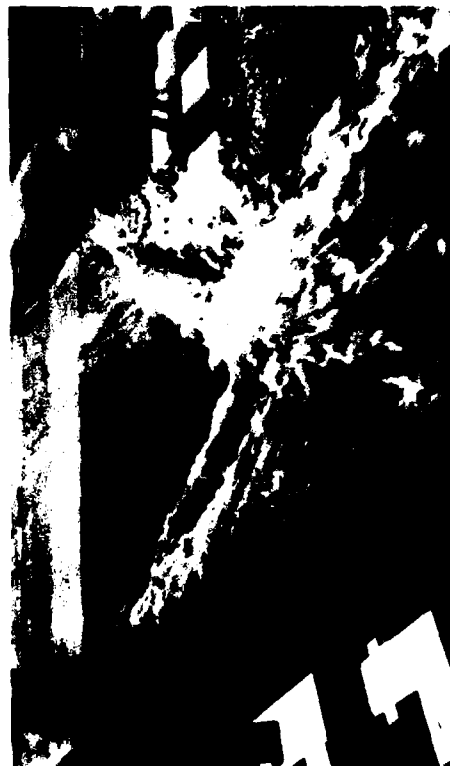
Photograph 32. Discharge 24,000 cfs

Photograph 33. Discharge 45,000 cfs

Photograph 34. Discharge 91,700 cfs

Plan C Stilling Basin Without End Sill

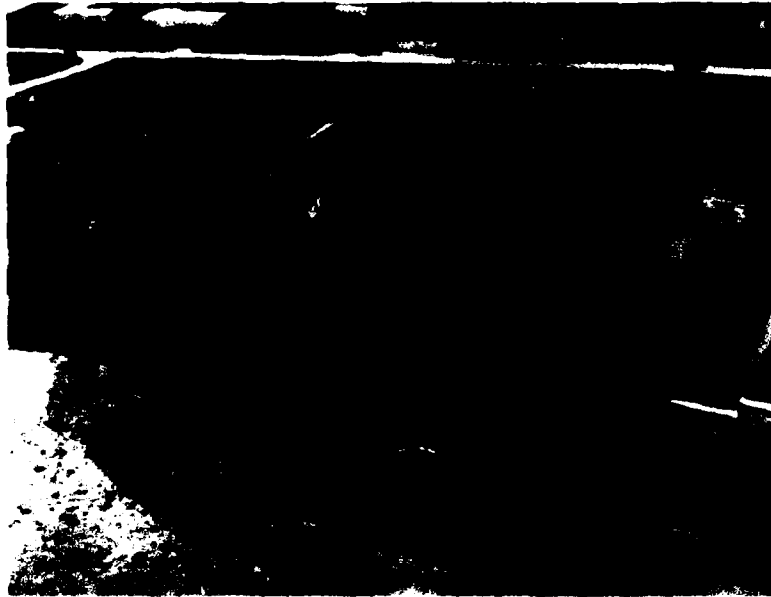
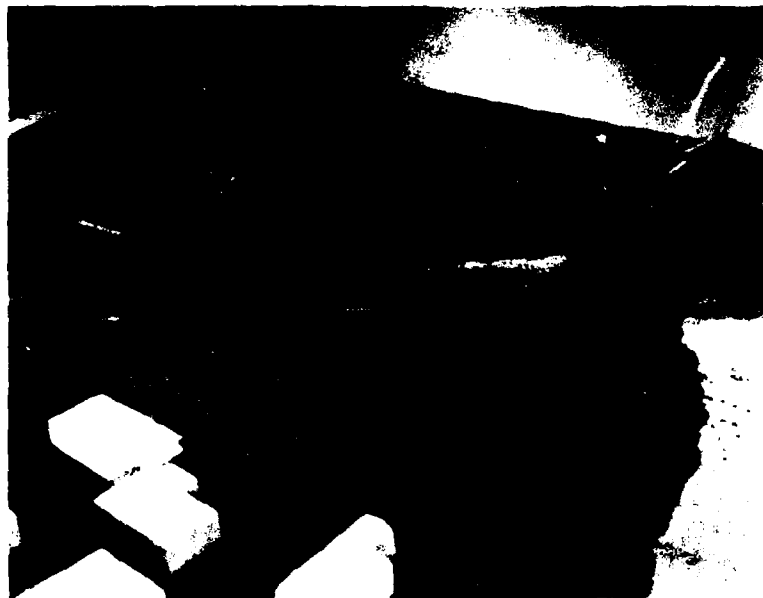
Photograph 35.

Looking downstream from left bank

Looking upstream from left bank

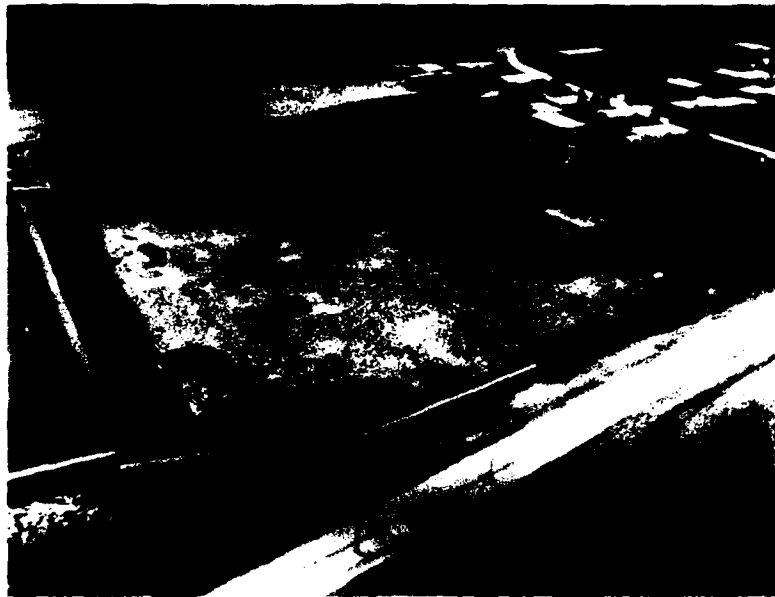
Photograph 36.

Looking downstream from right bank

Looking upstream from right bank

Deposited Spall From Spillway Chute

18. The spillway was modeled with a smooth surface to create maximum energy at the stilling basin for testing of the basin. During the studies the decision was made that the face of the spillway chute would be the outer edge of the compacted concrete of the dam which would be subject to some spalling during spill. The effect of spalling on flow conditions in the basin and downstream was studied with the Plan C basin and unscoured overburden downstream by slowly adding 1,700 cubic yards of spill material to the chute as spill increased from no spill to 18,000 cfs, and then flow was slowly decreased to no spill again. Approximately 50 percent of the material was deposited on the right bank of the outlet channel (photographs 35, 36, and 37). A log of observations during the test is listed in table 1.

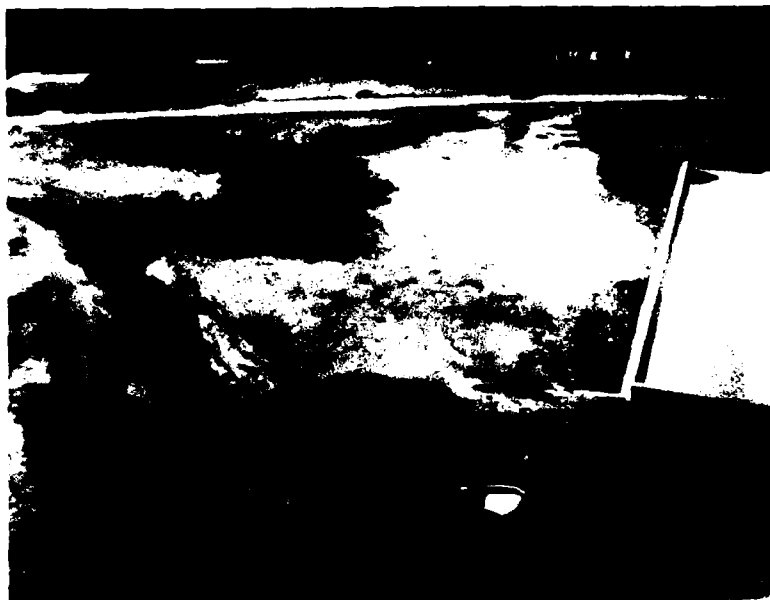
Photograph 37.

View from left bank

View from right bank

Deposited Spall From Spillway Chute

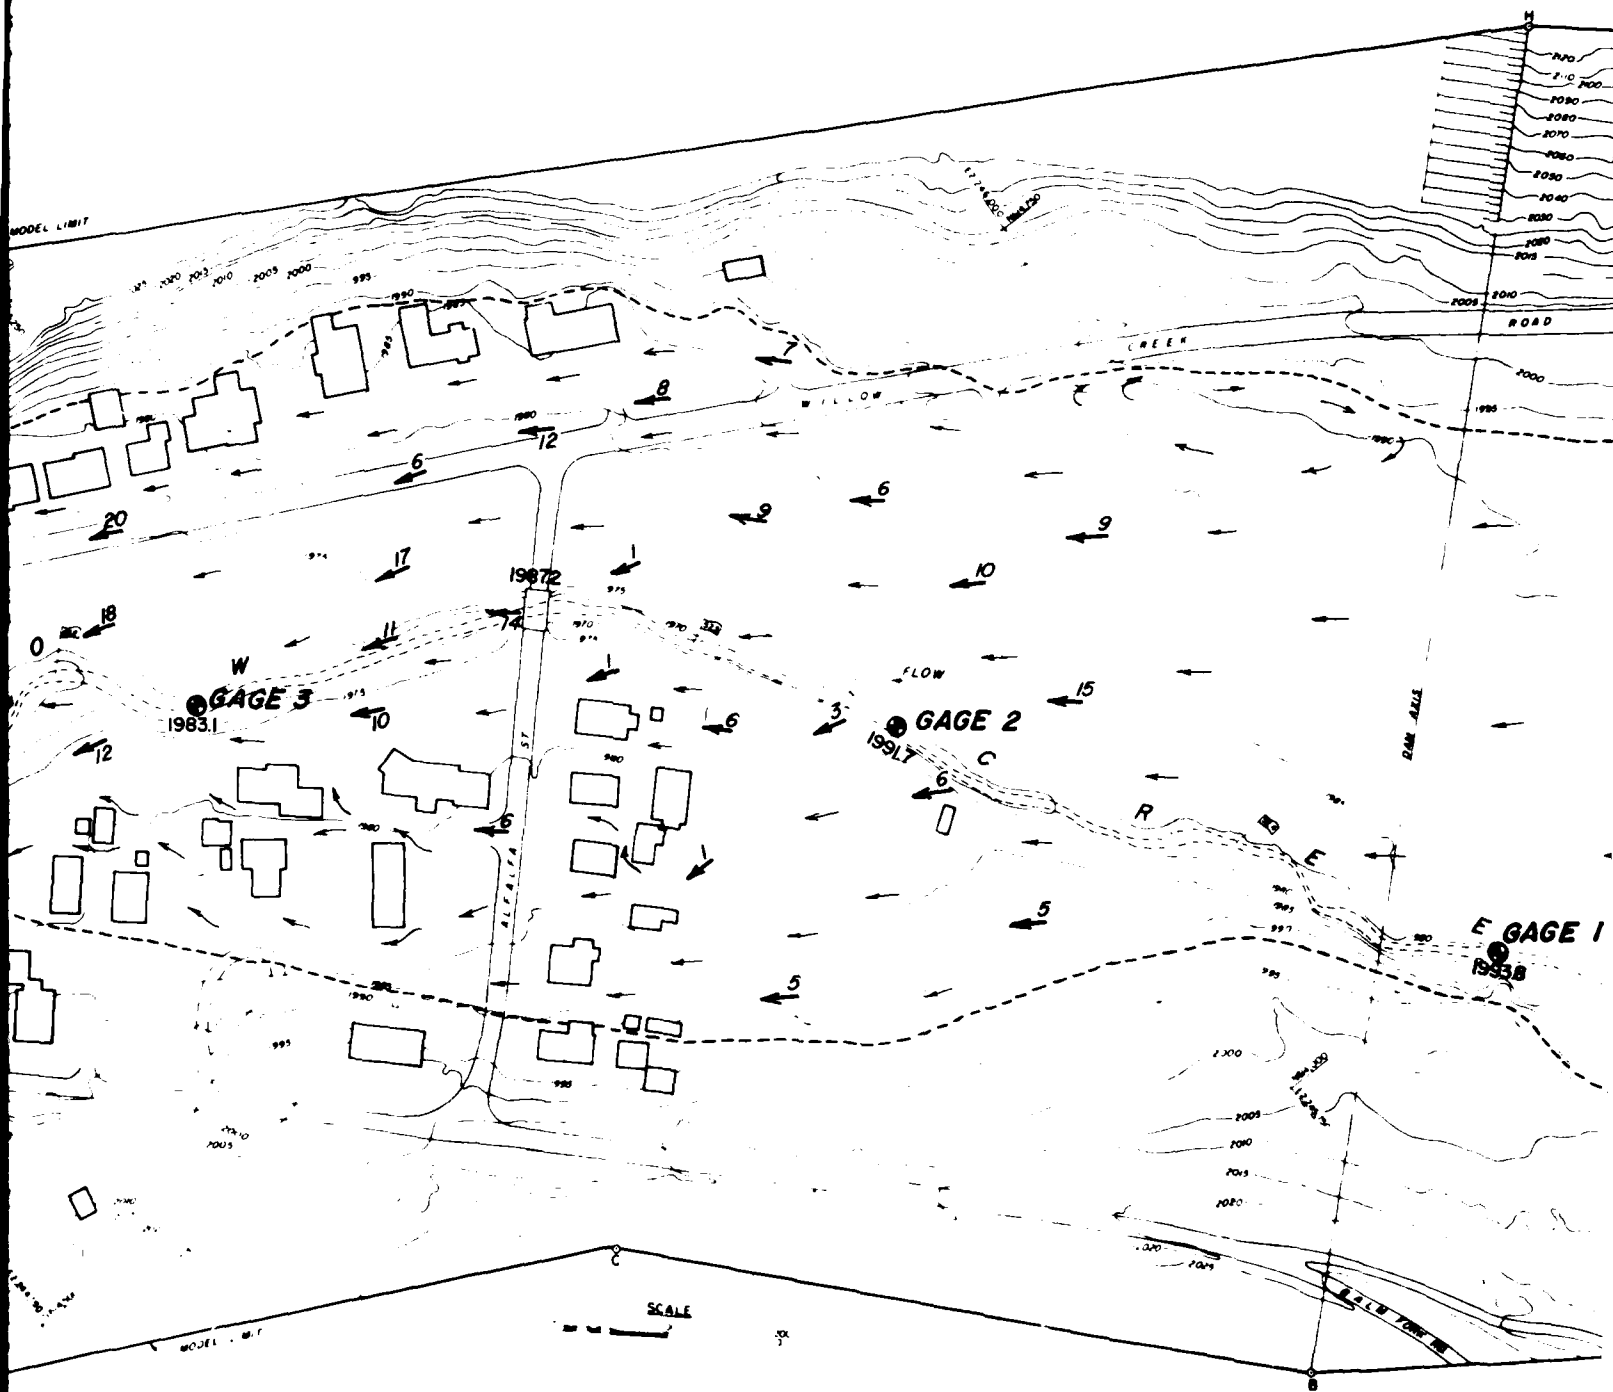
- ← 6 VELOCITY 3 FT ABOVE BOTTOM IN FPS
- SURFACE FLOW DIRECTION
- - - WATER'S EDGE
- 1991.7 WATER-SURFACE ELEVATION IN FEET

UNREGULATED STANDARD PROJECT FLOOD

DISCHARGE 45 000 CFS

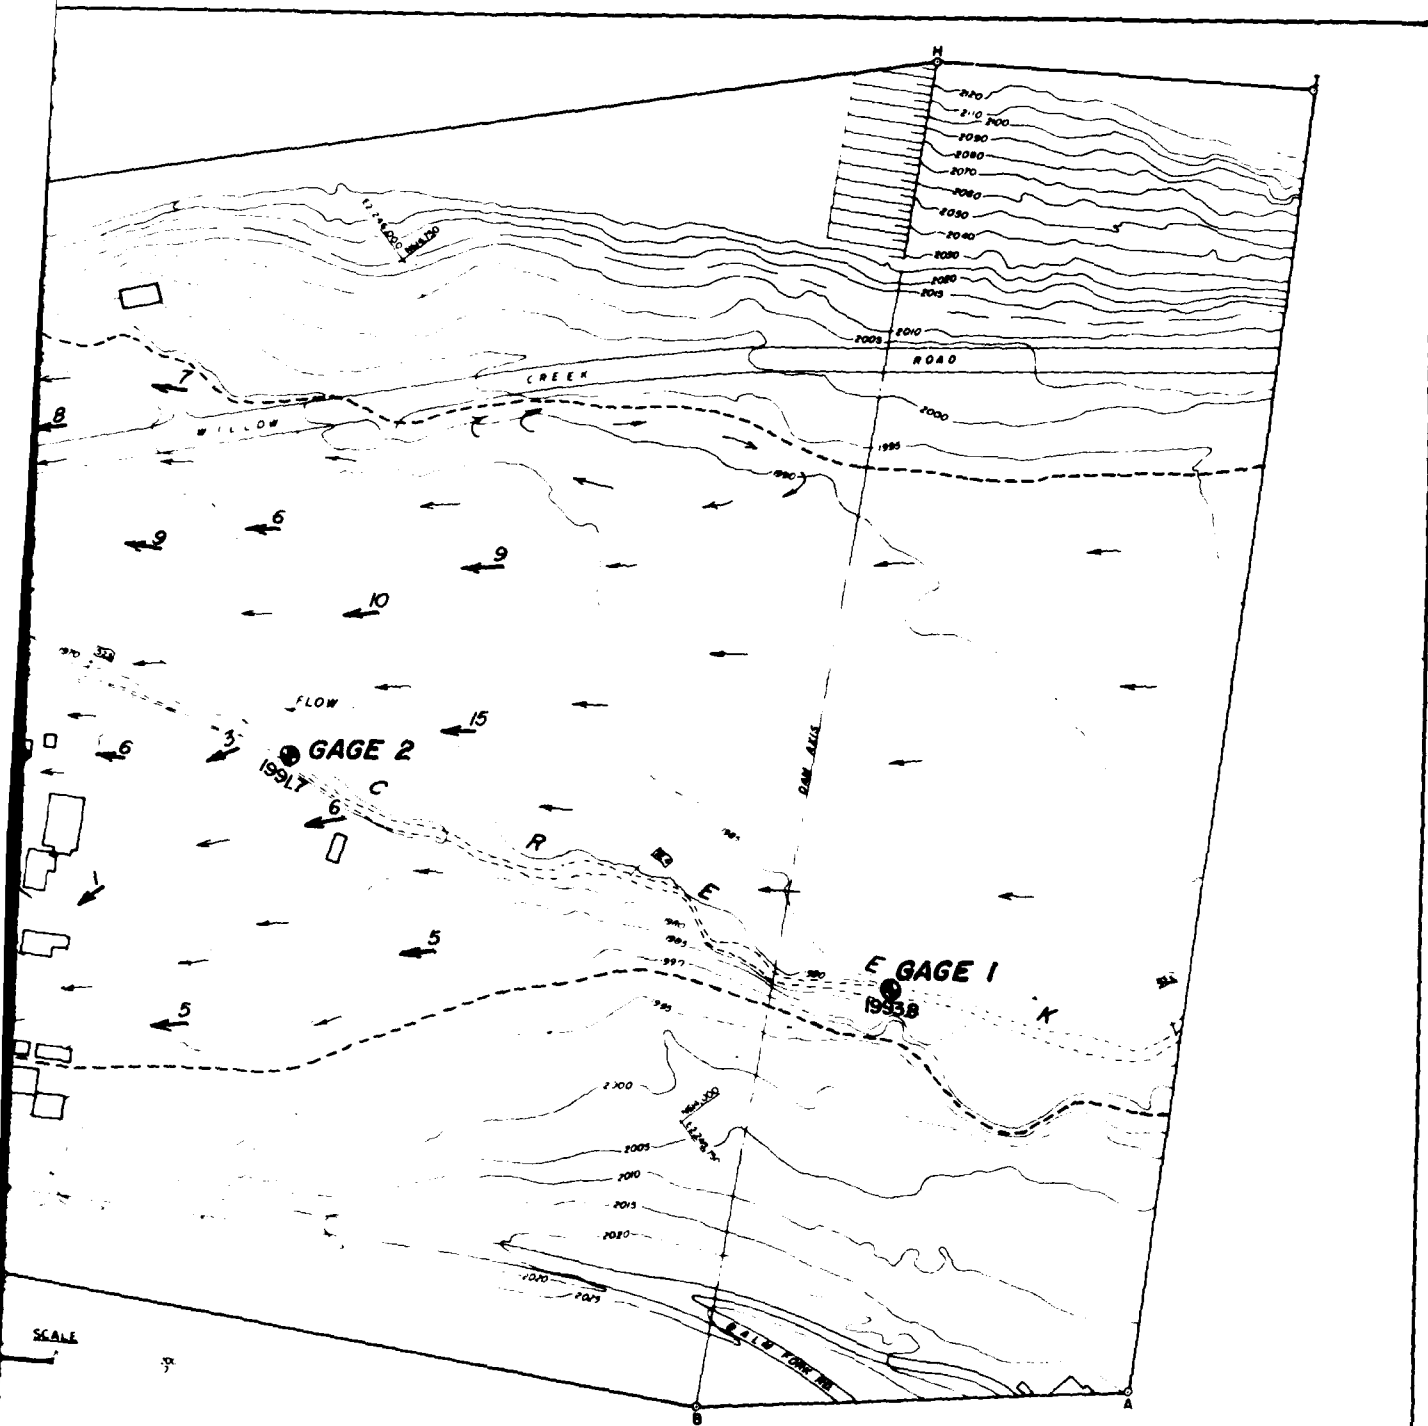
FLOW CONDITIONS
